PTO 101

Introduction. This information was collected from numerous posts on the Country Coach Yahoo Group site. Many list members contributed, especially George Harper, Bob Handren and Roger Uhlich, who all provided photographs. PTO 101 was edited by Lee Zaborowski.

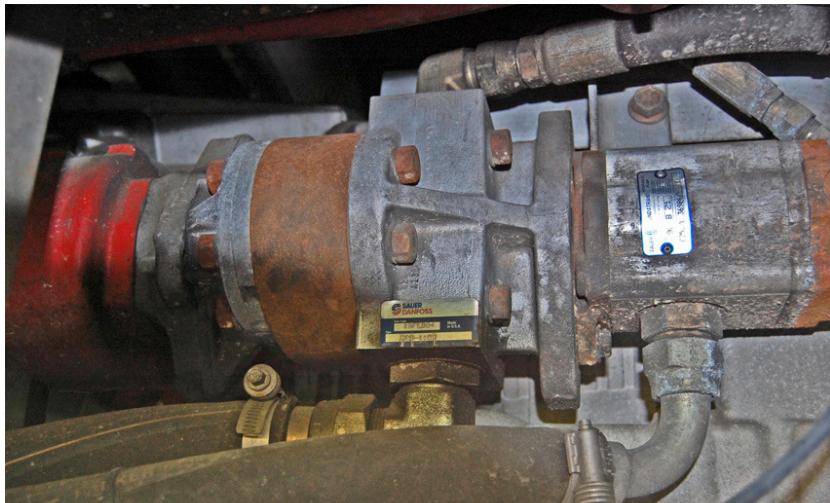
From the left, PTO, hydraulic system pump, power assist pump.

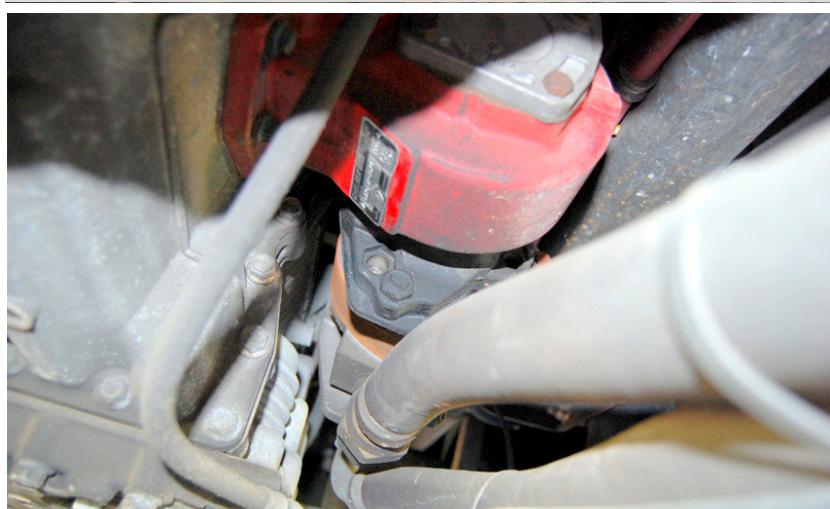
PTO with two pumps on passenger side of coach.

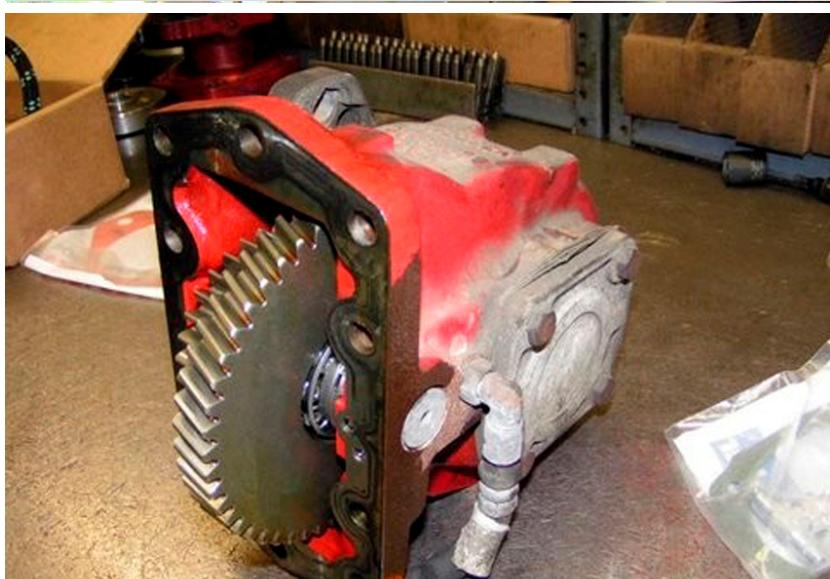
PTO showing single hose connection.

To determine if the PTO has a wet design count the number of small diameter (~3/8" OD) hoses attached to it. If there is one hose from the Allison transmission this lubricates the PTO drive gears but not the pump drive shaft. If there is a "T" and two lines this should be a "wet" design and the second line provides lubrication for the pump's drive connection (see photographs).

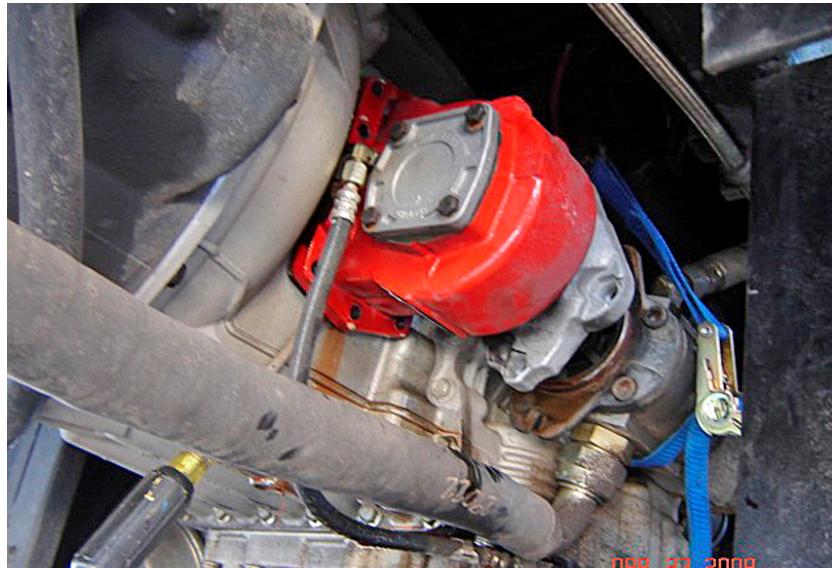
PTO removal in process, note single lubrication line.

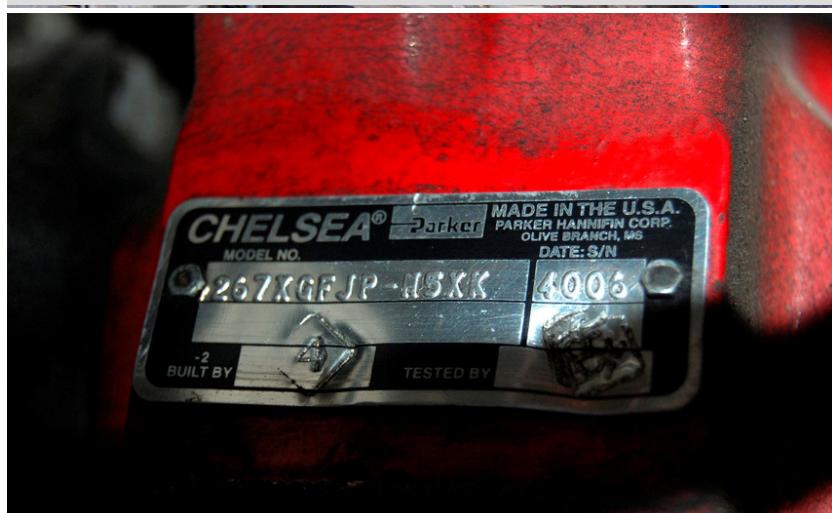
Data plate.

If your CC has a PTO it probably has the following Model Number Designation.

267XGFJP-M5XK

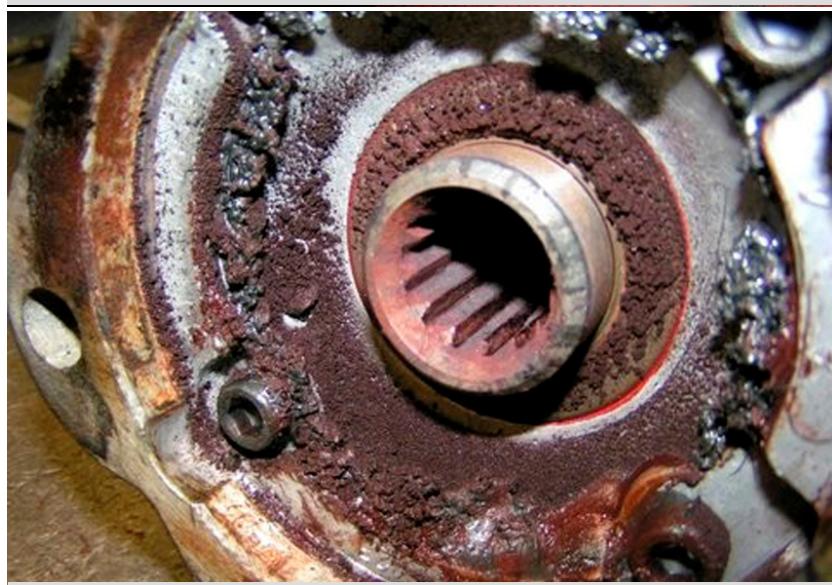
The worn shaft splines are also courtesy of George Harper's 2004 Allure with a Cummins 400 ISL at 43,000 miles.

Worn PTO output shaft.

Bottom line is anyone that has a dry Chelsea PTO better get the wet kit installed. Per Chelsea, it will fail around 30,000 miles if it's dry. You can spend a little now, insurance per say, and probably never have a problem. The alternative is at some point it will fail leaving you stranded and possibly causing a tow and a new pump, costing 5 times or more what the wet kit is and ruining a trip.

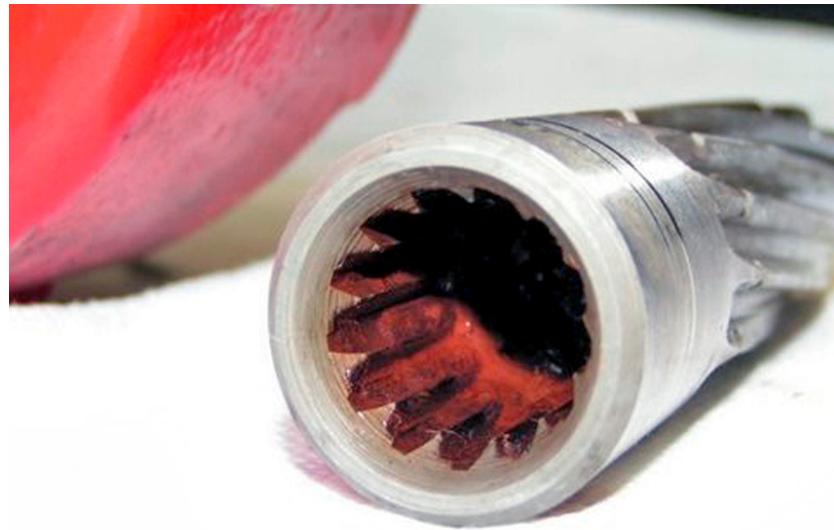
Close-up of old, worn output shaft, VERY close to failing.

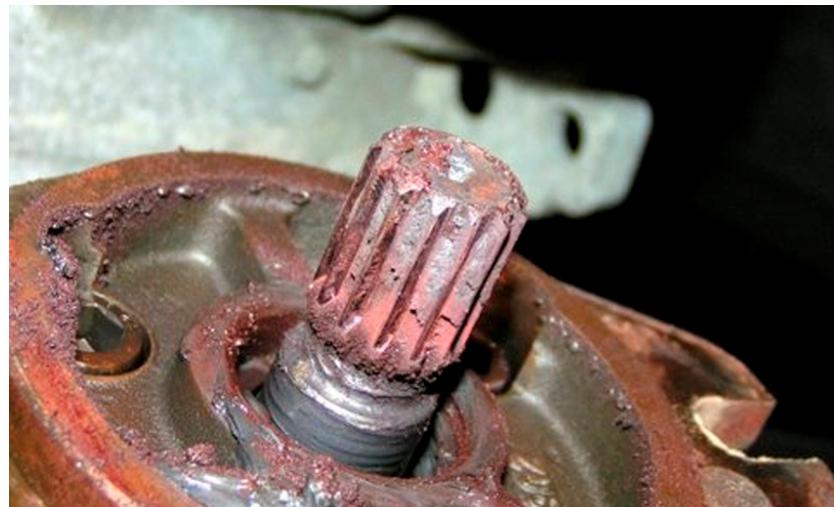
Worn pump input shaft.

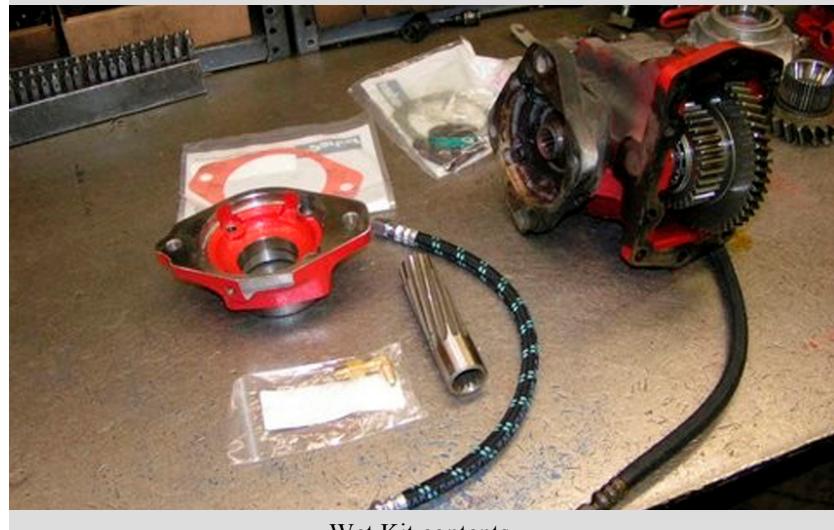
Wet Kit contents.

The wet kit for this model PTO is Chelsea-Parker Part Number 328591-141X.

You will also need the gasket that goes between the PTO and the Allison Transmission. This is Chelsea-Parker Number 35-P-74.

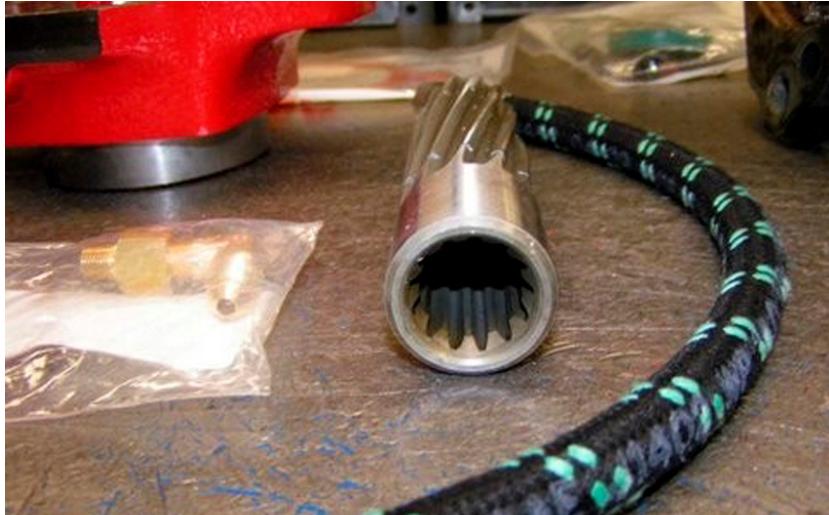
New PTO output shaft and hose.

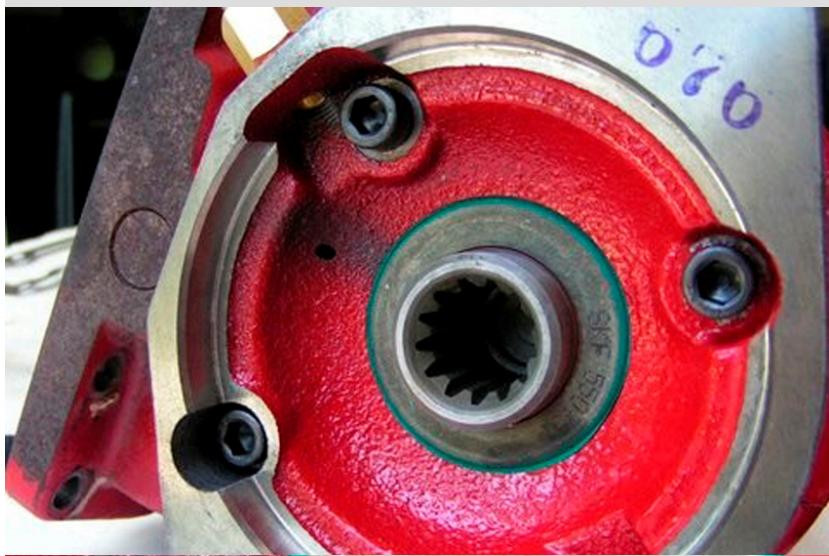
Wet kit installed – new housing and output shaft.

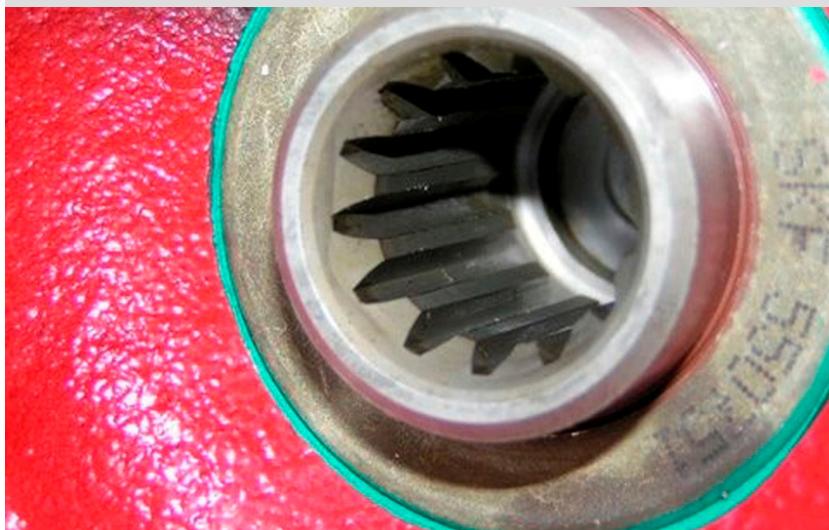
Close up of new PTO output shaft splines.

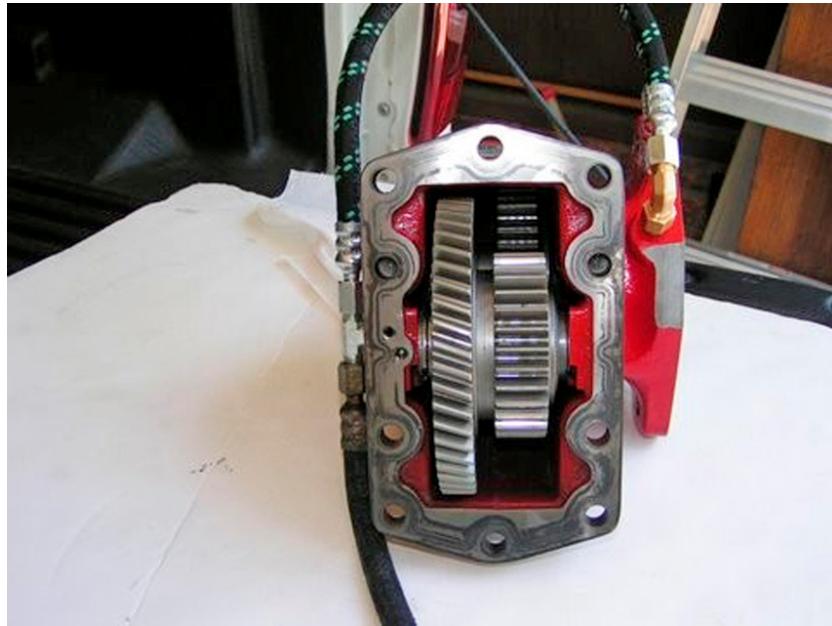
Wet kit installed, note “T” fitting and two lines. One goes to the transmission the other the PTO/pump drive connection.
